## Stripping for health

*PROSOCO and the Old Health Building*

Covered with one coat of paint after another since 1927, Raleigh, N.C.'s Old Health Building, built in 1898, finally gets to show off its beautiful masonry following a 2006-2007 paint removal and exterior restoration.

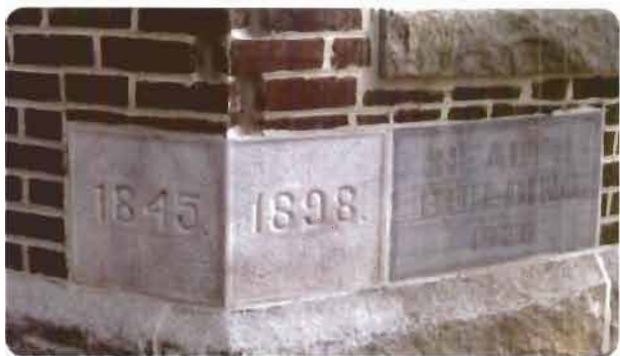
Cornerstones mark the date construction began on the North Carolina School for the Blind and Deaf (1845), the date the dormitory construction began (1898) and the date the State Board of Health moved in (1928).
